STRUCTURAL ENGINEERING REPORT

Structural issues observed at

Tauhara College
Invergarry Road
Taupo 3330

SHL5495 – 1 July 2021

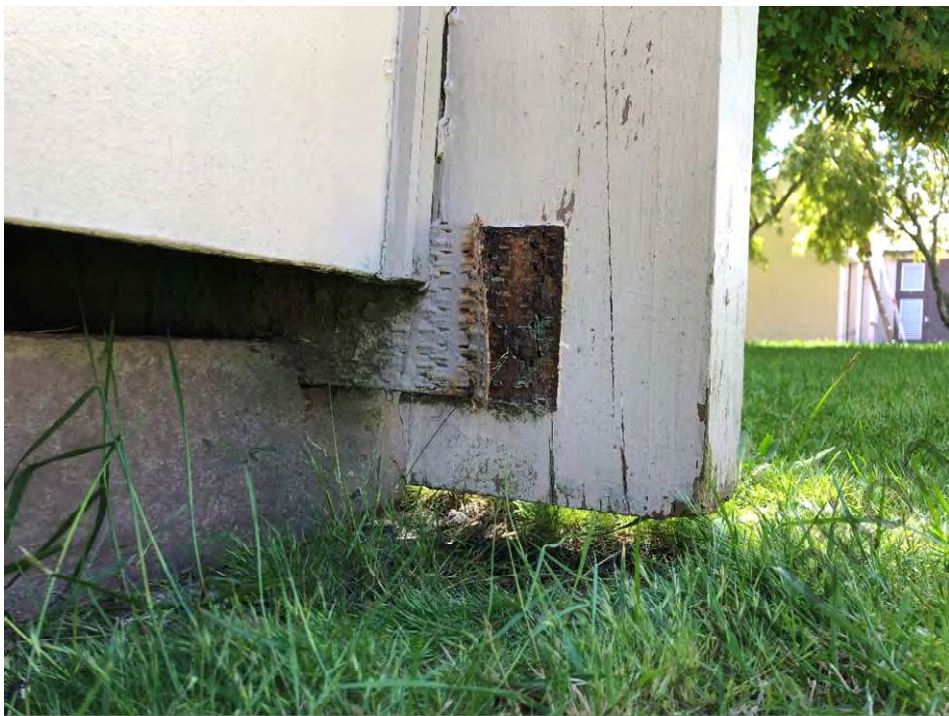
As is typical with the CEBUS system, the legs of these frames are external to the building fabric and therefore exposed to the weather. Some of the legs do not appear to have been well maintained over their circa 40+ years of life. Splitting and checking of the timber is common. The bases of these legs do not appear to have been sealed and in some cases are very decayed. In places the bases of the legs are very close to ground. The connections of the portal rafter to the legs at eaves level, as well as the legs to the posts/bearers at floor level consist of steel gangnail plates. Corrosion of the steel on these is common. In some locations the gang nail plates have separated from the members, indicating a loss of strength in the connection. In some locations the legs appear to be bearing on a very small area (~50mm x 50mm).

Figure 1: Example of portal leg near ground with gang nail plate separation at Block R

As these portal frames are the primary gravity and lateral structural elements for these buildings, Sullivan Hall suggests the existing timber structural members and connectors are individually assessed and remediated where necessary.

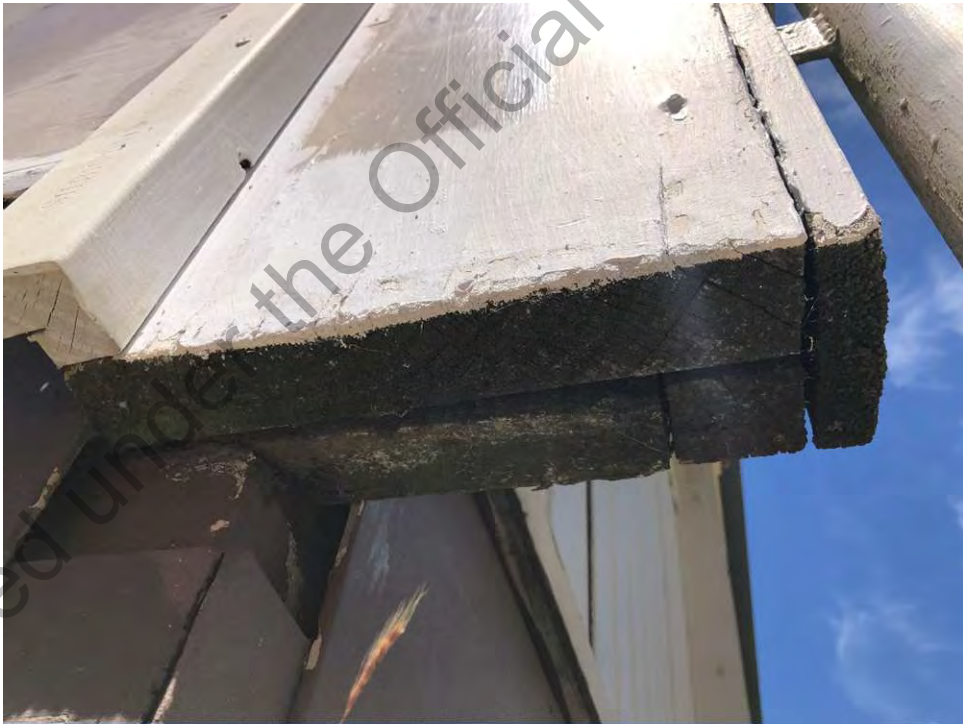
Figure 2: Example of portal leg with decayed timber and minimal bearing at Block B

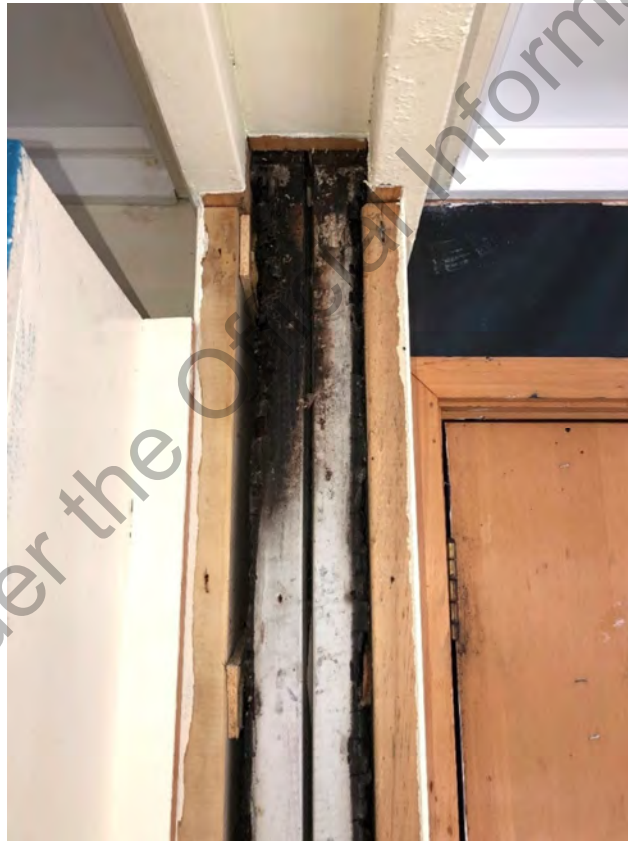
Fire damage and charring was noted on a timber column in Block B. We are unclear on the extent of this damage beyond what was exposed at the time of our visits. In our opinion, the structural capacity of the column has been compromised and if the building is to remain, any structure with fire damage exceeding a charring rate of ~10% of the cross-sectional area would likely need replacing.

Figure 3: Fire damage to structural column at Block B

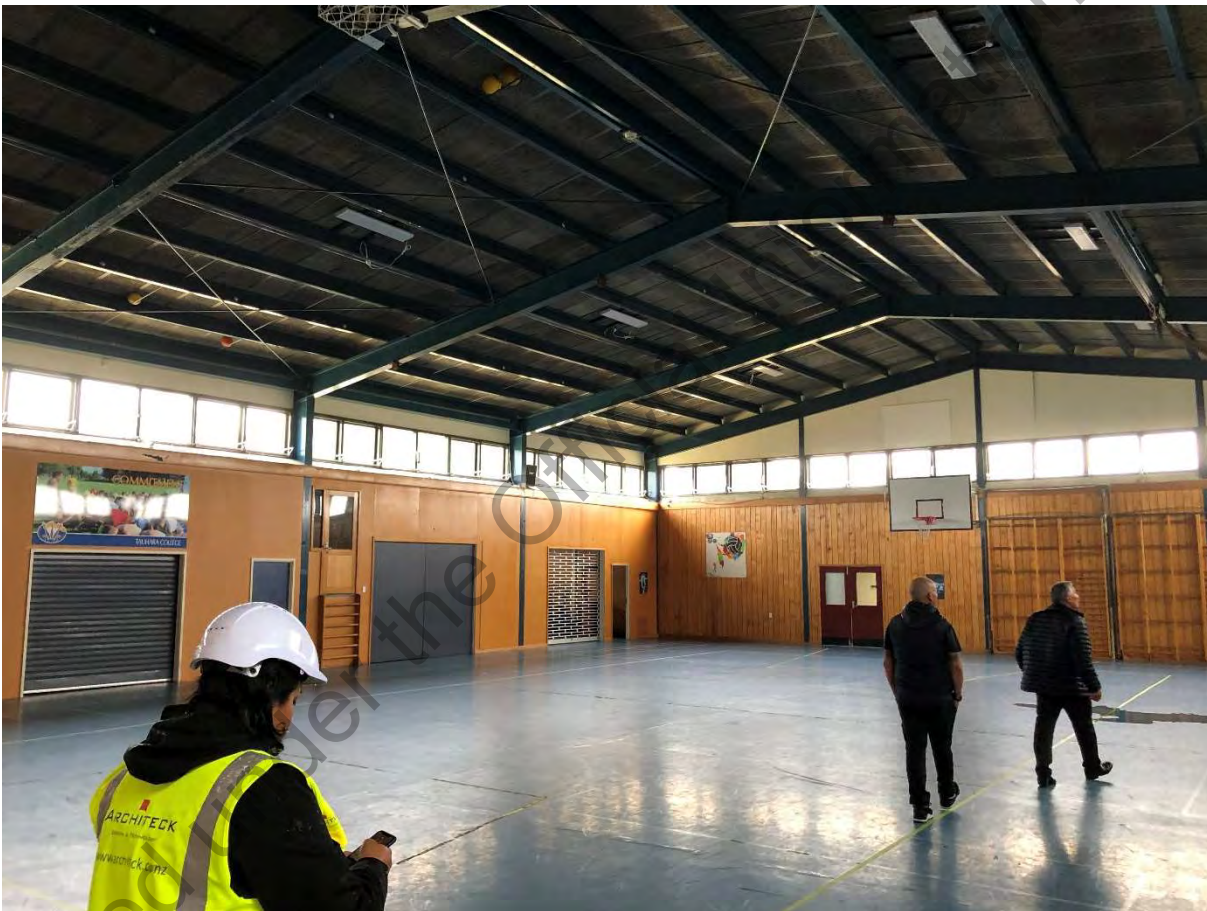
While weathertightness issues are evident, the structural integrity of this building generally appears to be good. The main gym area consists of steel portal frames and light steel purlins. These appear to have been well maintained.

Figure 4: Gym interior

External and internal linings to the timber framed lean-to portions of the building should be removed and wall framing and roof framing to these areas should be assessed and replaced as needed.

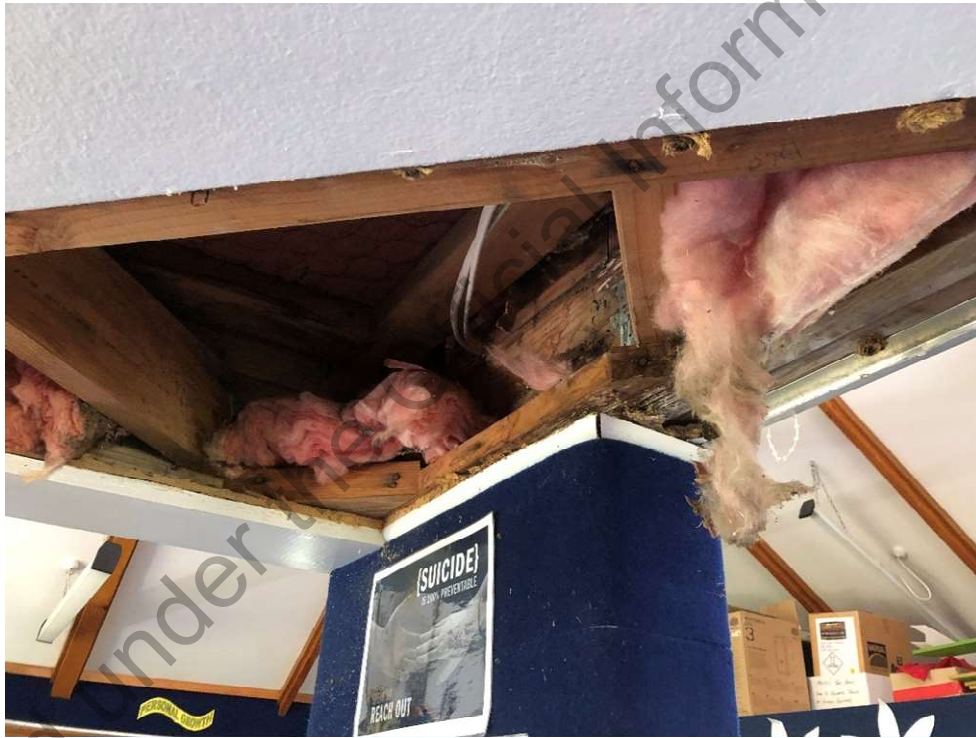
This building also appears to have suffered from ongoing issues with weathertightness in the roof. Previous recent repairs to internal linings were evident. As with the classroom blocks, the sample of structural roof members observed suggests decaying timber is an issue for the roof structure of this building.

Given the numerous roof plane angles, junctions and internal gutters, the issue is likely to continue even if the decayed structural elements are replaced. Sullivan Hall's recommendation would be that the roof is redesigned and reconstructed to rationalise the roof planes / gutters, which in the process would replace the roof structure.

Figure 5: Evidence of decaying roof structure at Library

Ultimately the findings and suggestions within the August Millard report should form the basis of a replacement schedule on the timber in this building.

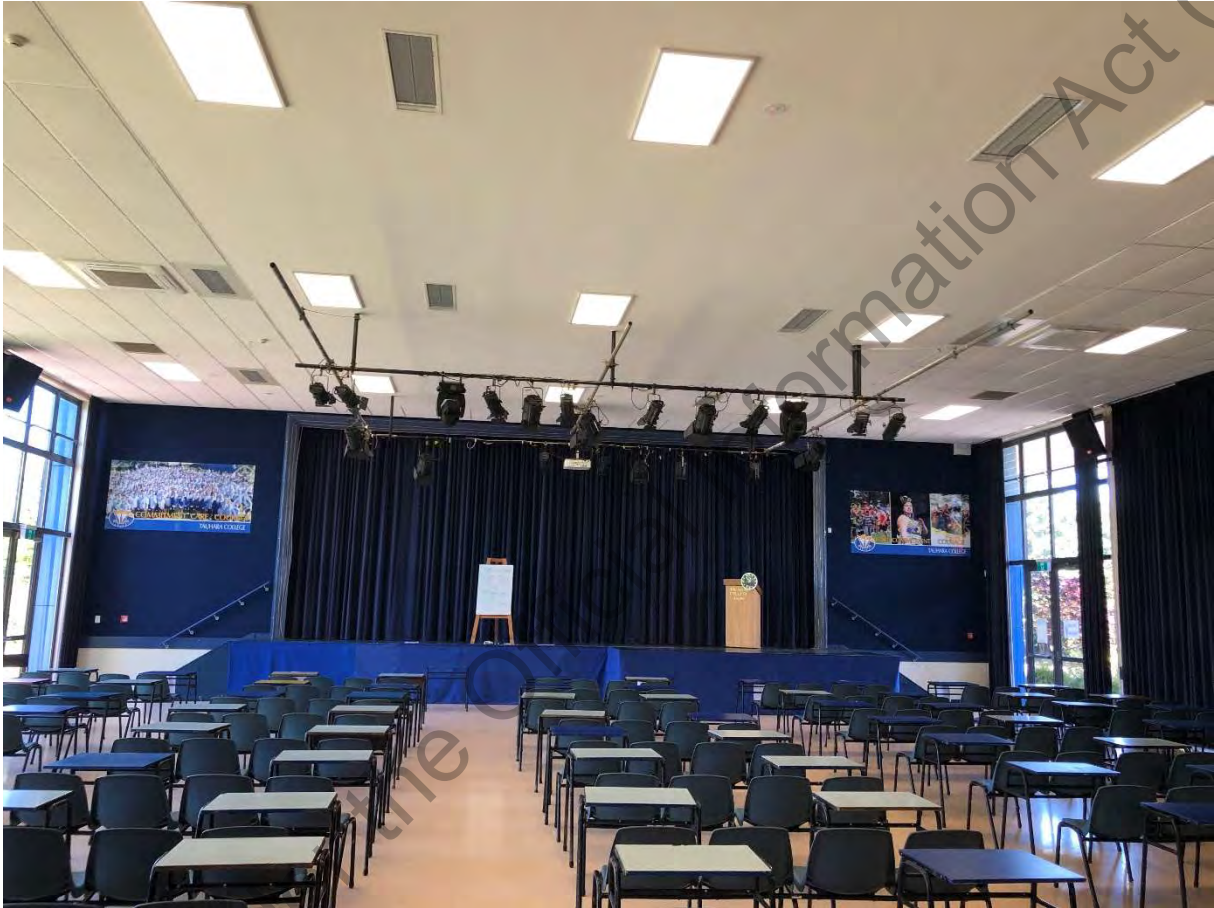
The property file indicates that the building works were consented in early 2007. It is Sullivan Hall's opinion as structural engineers that the building visually appears to be undamaged structurally.

Figure 6: Hall interior

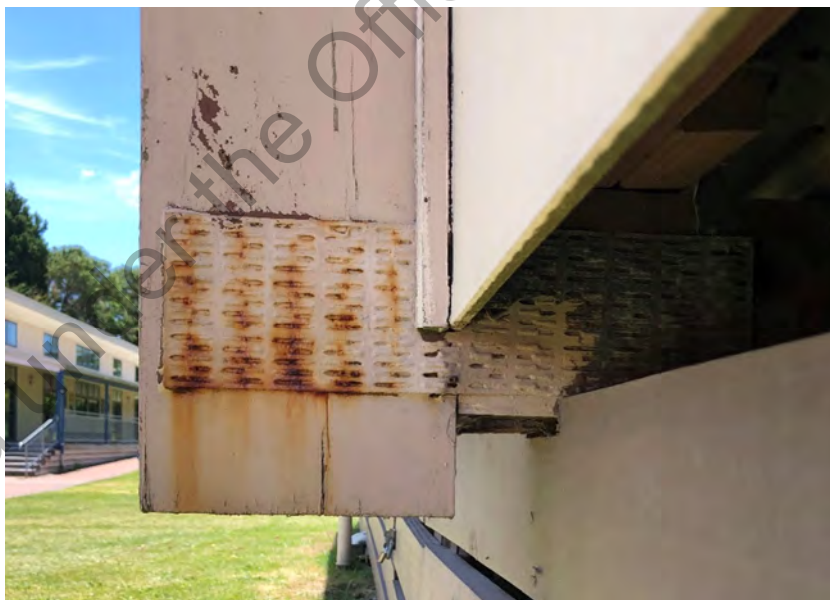
This building appears structurally similar to the typical CEBUS system however it has a number of differences. The key structural difference is in the portal leg-bearer detailing. Where the typical CEBUS connection detailing introduces a moment couple between two gangnail plate pairs (allowing moment transfer from the leg to the bearer), the equivalent connection in R Block at Tauhara College has only a single gangnail plate pair as a 'pinned' connection. This discrepancy results in a reduced structural performance, as the 'box' portal frame synonymous with the CEBUS buildings is missing and replaced with a 'pinned' connection at the base of the leg.

This loss of rotational restraint increases the member moments at ULS, and deflections at SLS.

Figure 7: Portal leg-bearer connection - R Block

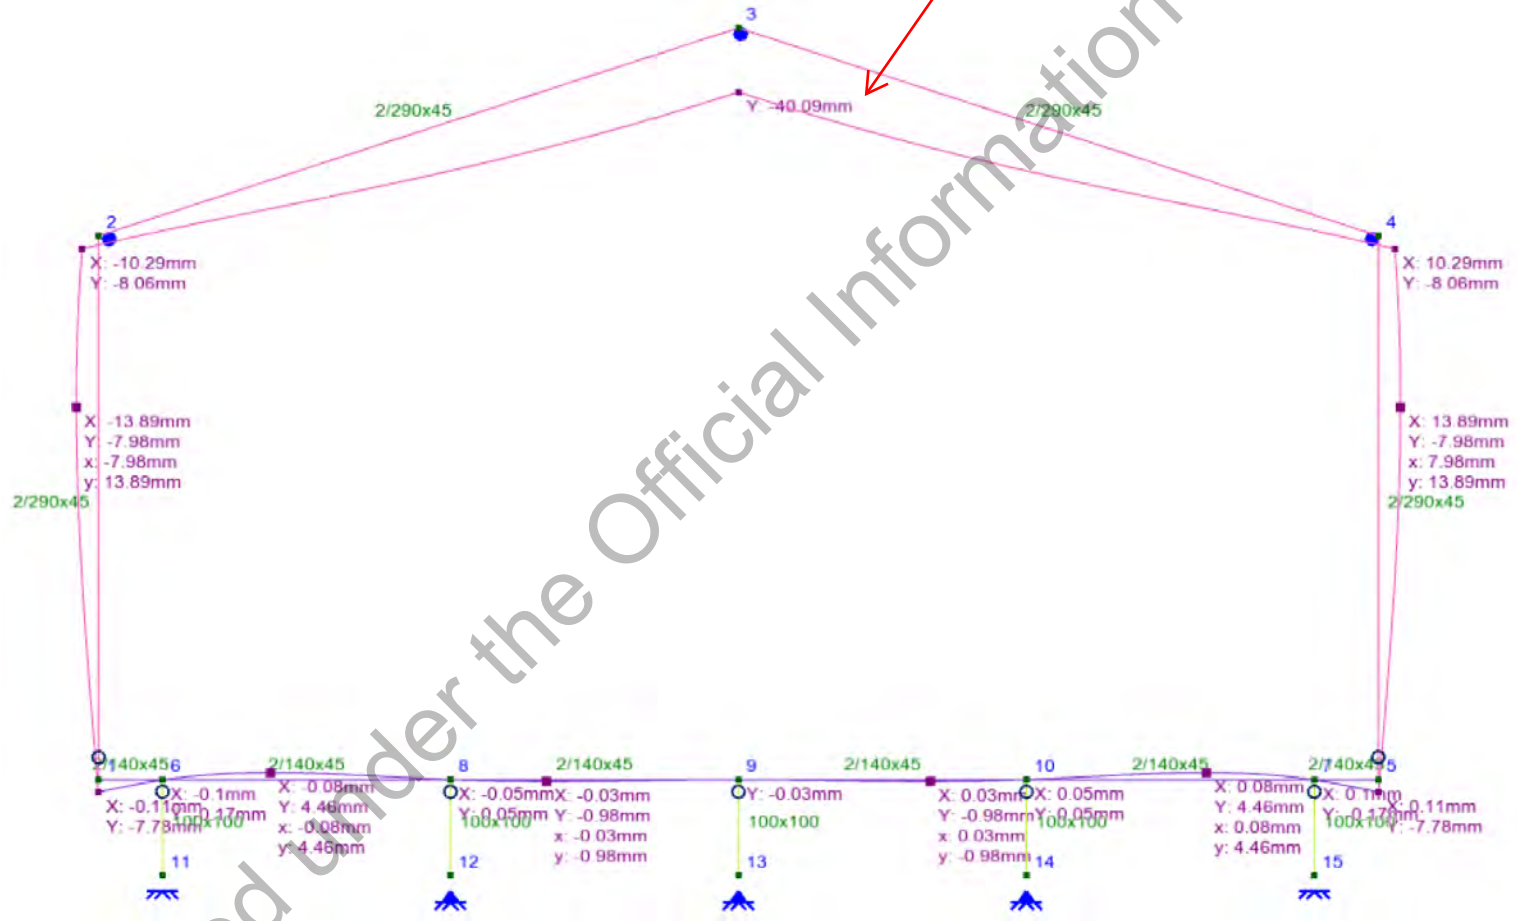
15 (SW) SLS 2G+0.4Q(dry)

max recommended deflection = $3000/300 = 10\text{mm}$
 actual deflection under SLS = 40mm

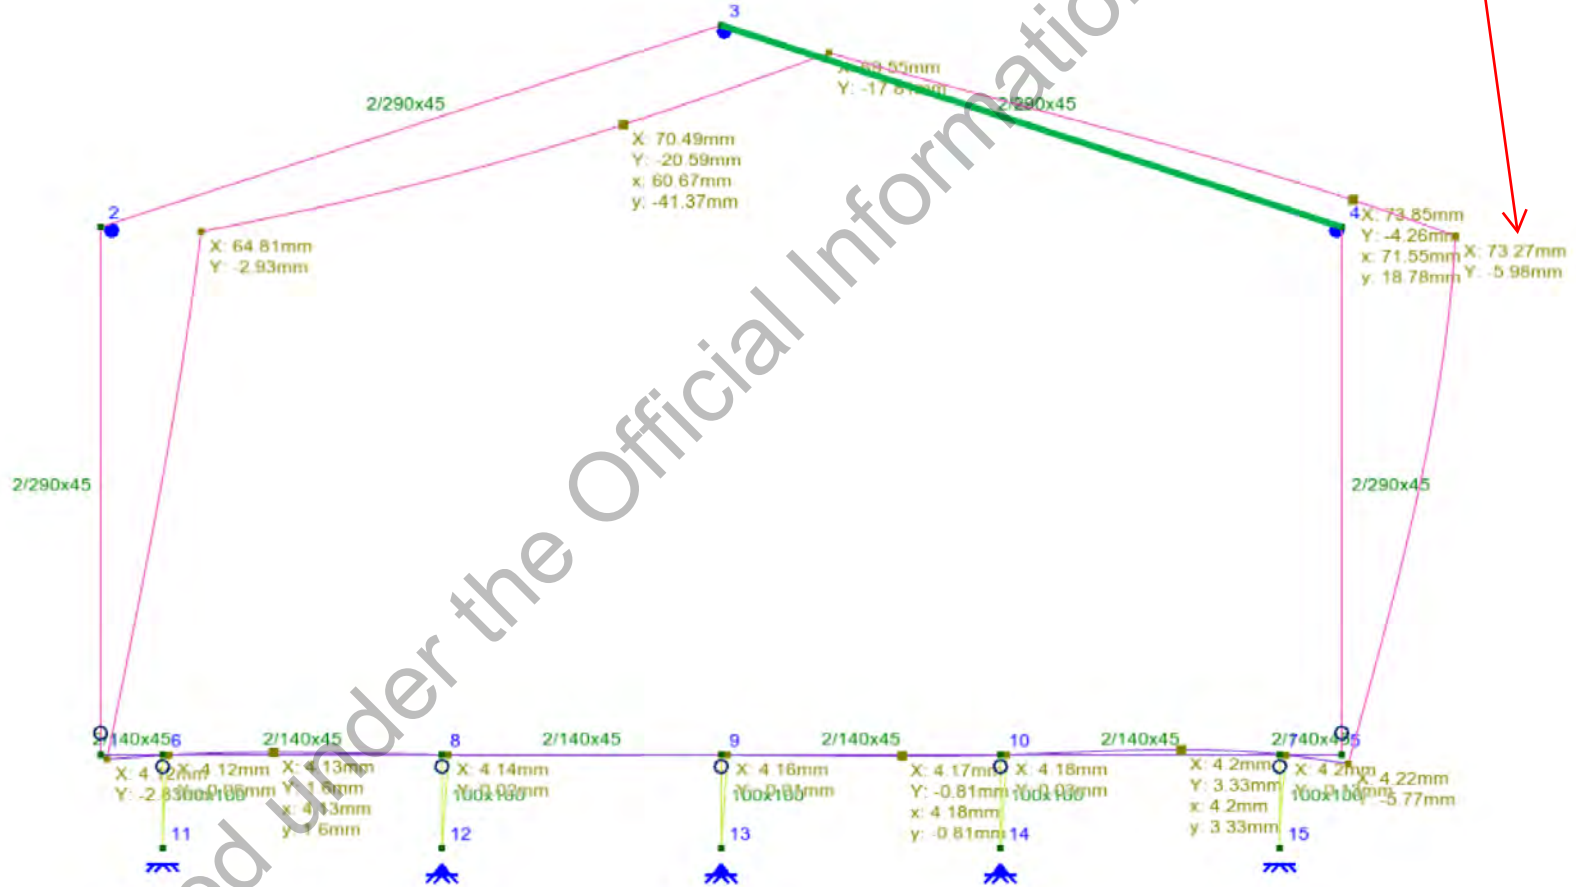
11 (SW) SLS G+0.4Q+Ws

max recommended deflection = 3000/200 = 15mm
actual deflection under SLS = 73mm
