STRUCTURAL ENGINEERING REPORT

Structural issues observed at

Tauhara College
Invergarry Road
Taupo 3330

SHL5495 – 1 July 2021

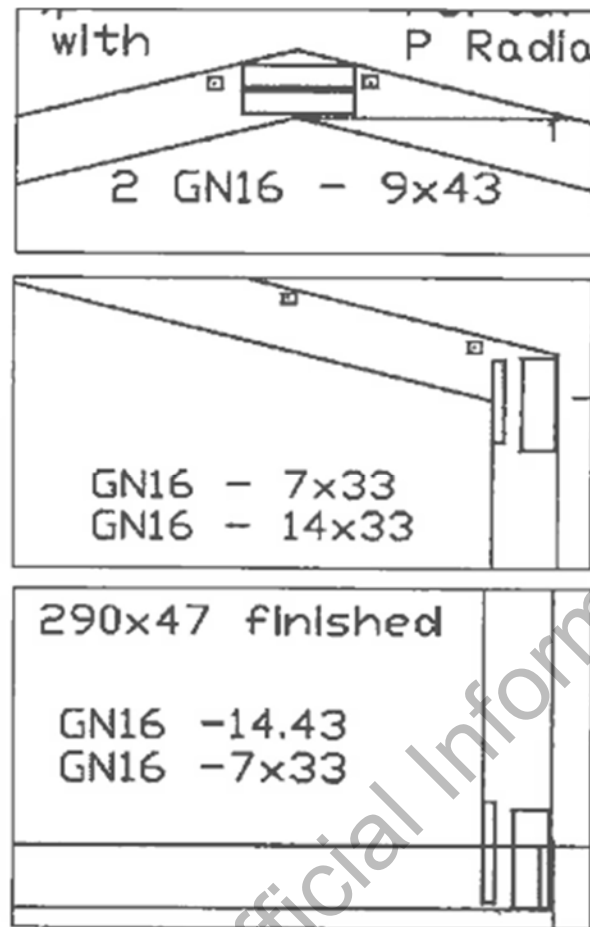
Figure 10: Typical CEBUS Mk 4 detailing

As mentioned above, the CEBUS system utilises timber connectors forming a moment couple and resulting in a 'box' portal frame structure with presumed moment rigidity on all sides.

As observed with the R Block, some external timber portal legs and gangnail plate timber connectors at Blocks A, B, C and D were observed on site to be in poor condition. For this analysis, we have assumed a remediation process will be undertaken and that the nail teeth are fully embedded into the timber, and that durability is not an issue.

Our opinion is that unsound timber and corroded steel connectors should be individually assessed and remediated or replaced as necessary. This remediation may involve specific engineered design work and would need to be undertaken by a suitable Chartered Professional Engineer.

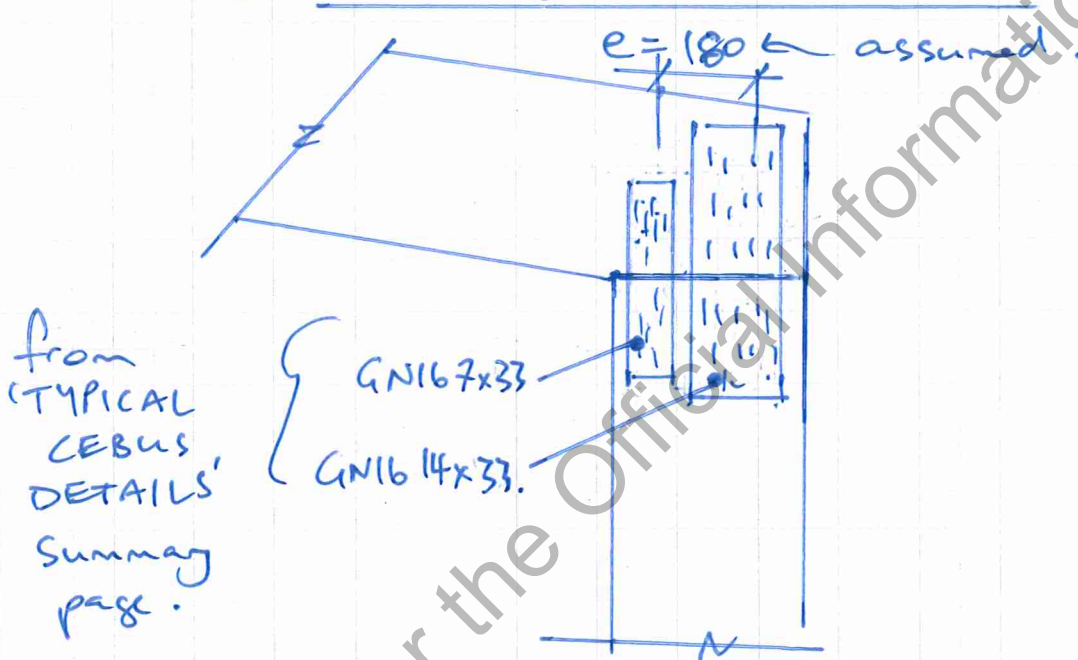
→ R-Block only has moment connection at top of portal leg.

→ CEBUS has connections at top + bottom of portal leg.
